Hoonah Geothermal Corridor Quality Assurance Report of DOT Roads To Resources Project.

**Alaska Department of Transportation
Roads to Resources Project
LiDAR & Imagery
Quality Assurance Report
Hoonah Corridor**

**Written by Rick Guritz
Alaska Satellite Facility
July 28, 2015**

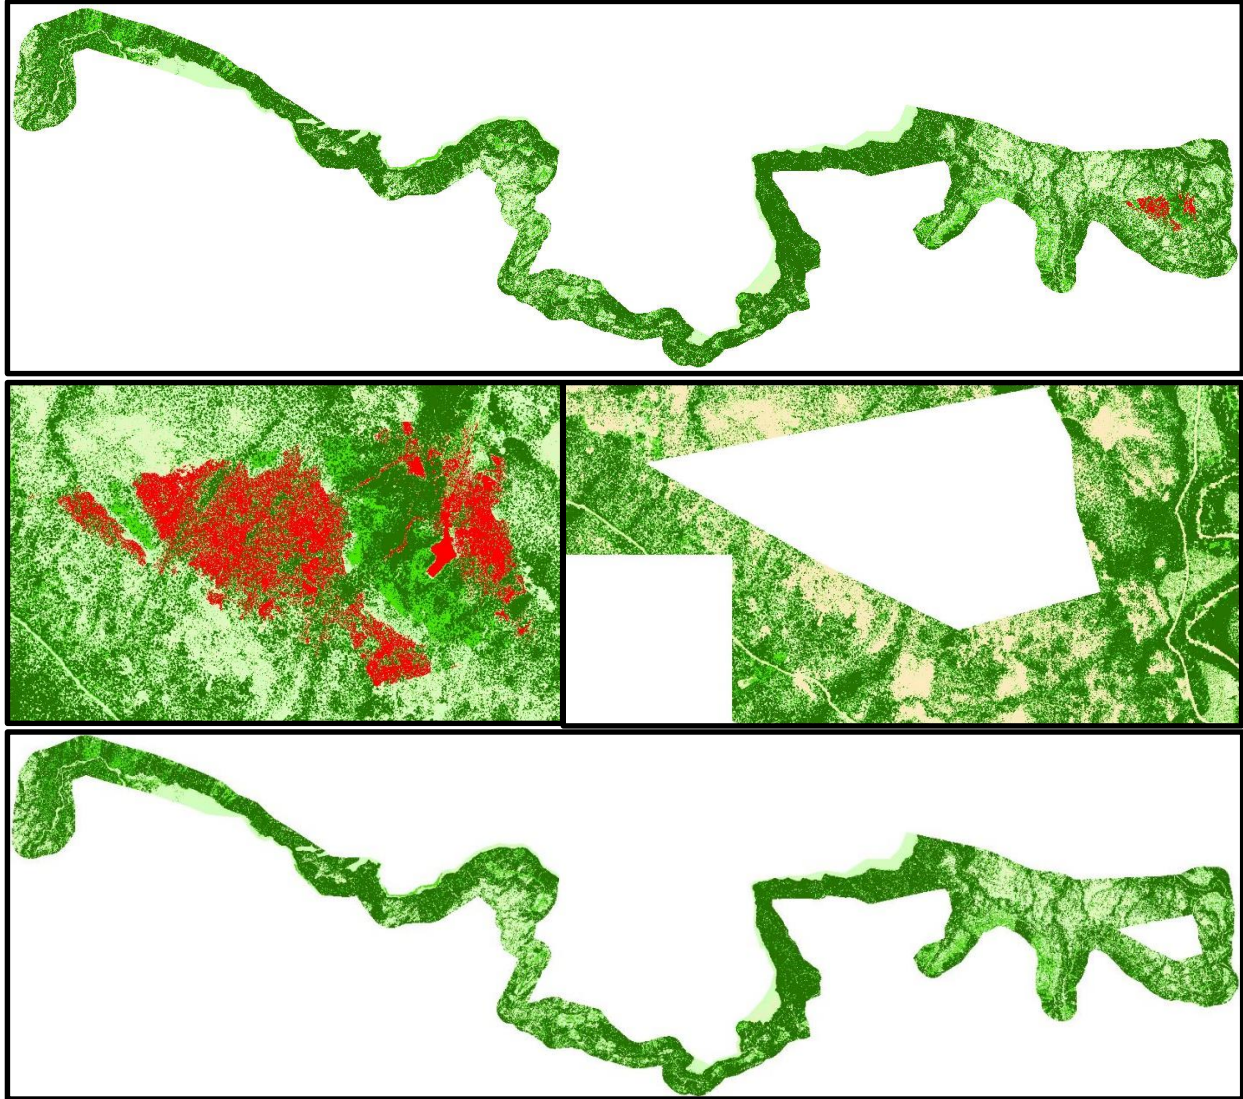
UAF completed its initial review of Hoonah Corridor – On 5/8/2015, UAF initial reports of data quality issues for Hoonah Corridor. These include: 1) the canopy height estimate which is first return DSM minus bare earth DEM should result in positive values related to above ground structure. In a small area of the Hoonah Corridor, there were larger than acceptable negative values. Areas of red indicate that the first return DSM is lower than the bare earth DEM (see Figure 31). In closer examination, values ranged from -1 to -10 feet roughly. 2) Land XML issues include: a) L22625_22525 – error loading tile saying that importing with face and neighbor info failed (see Figure 32). b) L22850_22400 – tile loads but is larger in size than other tiles (see Figure 33). No error is reported, just the visual appearance of tile is incorrect overlapping neighboring tiles. c) L22425_22550 – tile missing, not included on delivery disk (see Figure 34).

Figure 31, Canopy height classification shows height errors on west end of corridor. The height error was within the omitted hole in boundary. Tetra Tech initially decided to deliver corridor without clipping. When the height error was detected, Tetra Tech was then asked to clip to original boundary.

Delivery 2 – Tetra Tech staged fixes for Hoonah Corridor on 6/4/2015. Redelivery for Hoonah as requested. This delivery included replacement tiles for first return DSM and bare-earth DEM tiles which needed clipping. It also redelivered the requested LandXML tiles that were identified needing fixes.

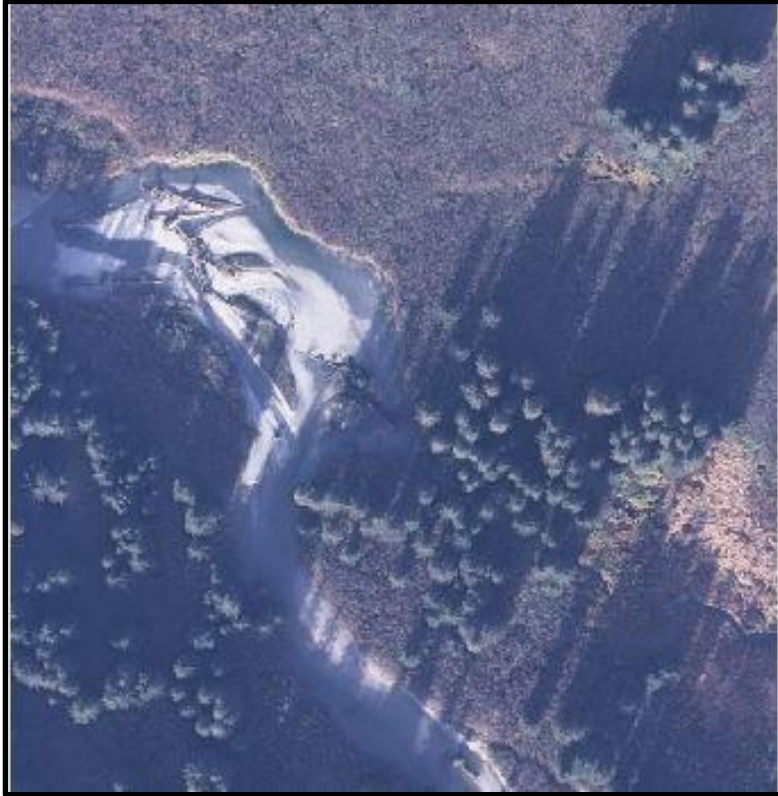
UAF completed the ortho imagery assessment of Hoonah Corridor – On 5/14/2015, UAF completed review of the ortho imagery deliverables for Hoonah Corridor. Significant shadows present on north facing slopes due to low sun angle conditions (see Figure 35). Also ortho-rectification artifact visible in imagery (see Figure 36). In consultation with Dan Ignatov of DOT, these image quality concerns are not a concern.

Figure 35, Low sun angle on north facing slopes and forests shadow impacted.

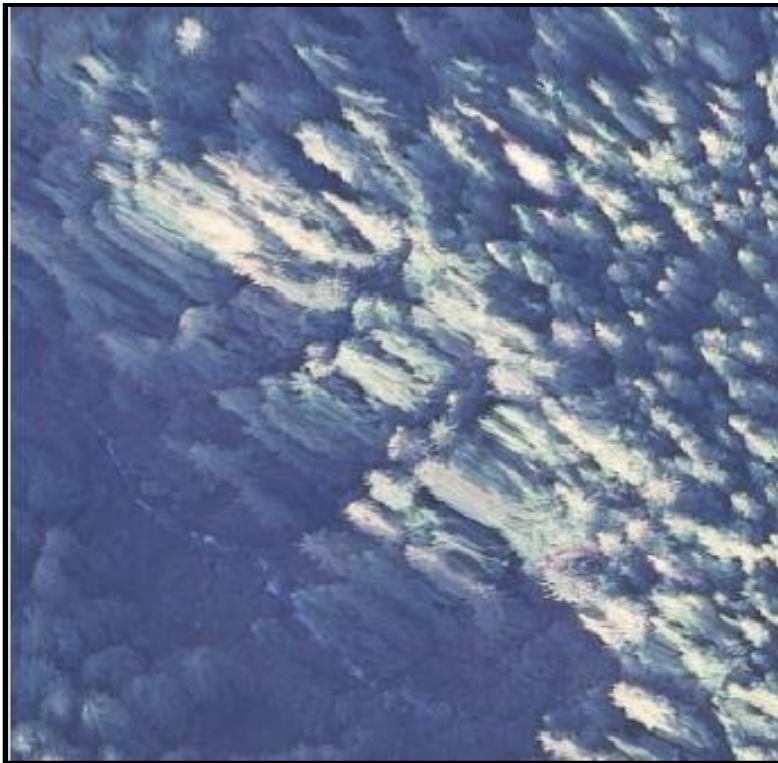
Figure 36, Ortho-rectification artifacts.

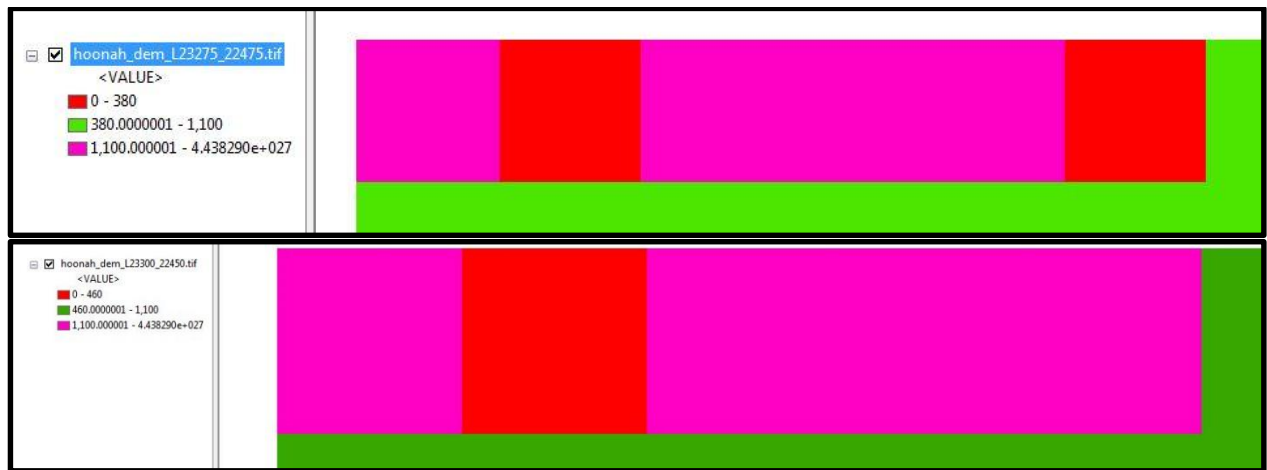
UAF verified some fixes and requested further work - On 6/15/2015, UAF completed quality Assurance review of delivery 2. The clipped first return DSM tiles and LandXML tile L22425_22550 were verified. The clipped bare earth DEM tiles has bad histograms with very large value ranges. Two of the requested LandXML tiles were still not fixed. UAF requested these to be fixed and redelivered.

UAF provided Tetra Tech further details on the data range anomaly - On 6/15/2015, UAF provided Tetra Tech further details on the data range issue affecting the bare earth DEM tiles that were clipped and previously delivered. UAF tracked the bad pixels to the first 6 pixels in the upper left corner of each clipped tile (see Figure 36). This might give Tetra Tech a clue to figure out its source. It looks like some sort of file header issue.

Figure 37, Zoom of the upper left corner of the bare earth DEM shows outlier pixel values, UAF expect this to be an image header issue. Tetra Tech traced the problem to a header issue in ERDAS software.

Delivery 3 – Tetra Tech staged fixes for Hoonah Corridor on 6/17/2015. Redelivery for Hoonah as requested. This delivery included replacement tiles for the bare earth DEM tiles with the upper right corners fixed, and two fixed tiles of LandXML contour products.

UAF verified delivery 3 fixes - On 6/22/2015, UAF confirmed latest delivery of bare earth DEM tiles and CAD Land XML contours fixed the remaining data quality issues. Hoonah corridor is now complete and recommend payment of final invoice to Tetra Tech. This was the last of five corridors.
